# GREEN ROOF DURABILITY: LESSONS FROM SANDY

Matthew Barmore & Elaine Kearney

RCI Convention & Trade Show. Anaheim, California

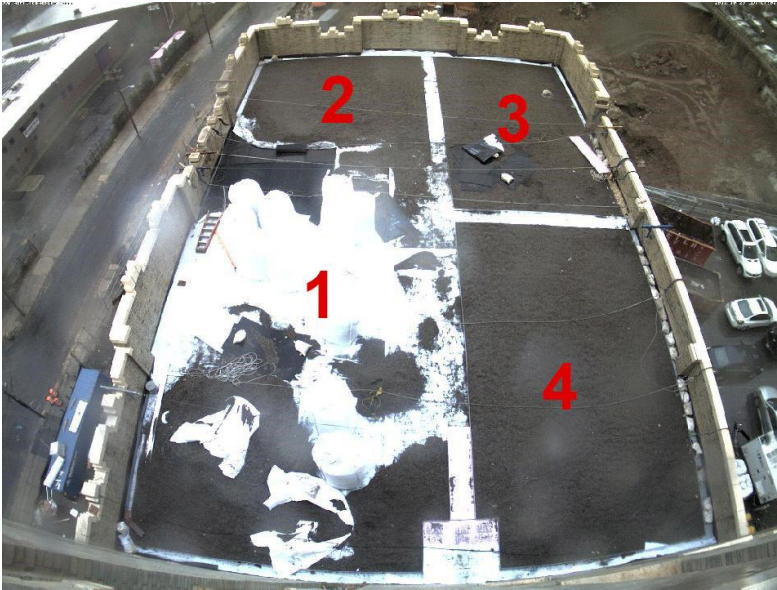
Figure 9: Post-storm conditions at Beacon Apartments green roof.

1. Roll-up of system components where edge metal system installation was unfinished, displacement of loose laid insulation; note the edges of green roof areas 2, 3, and 4, where at least some edge metal was already in place.
2. Displacement of loose laid insulation, windblown debris present.
3. Windblown debris present, but slight impact to the green roof system.
4. No significant impact.

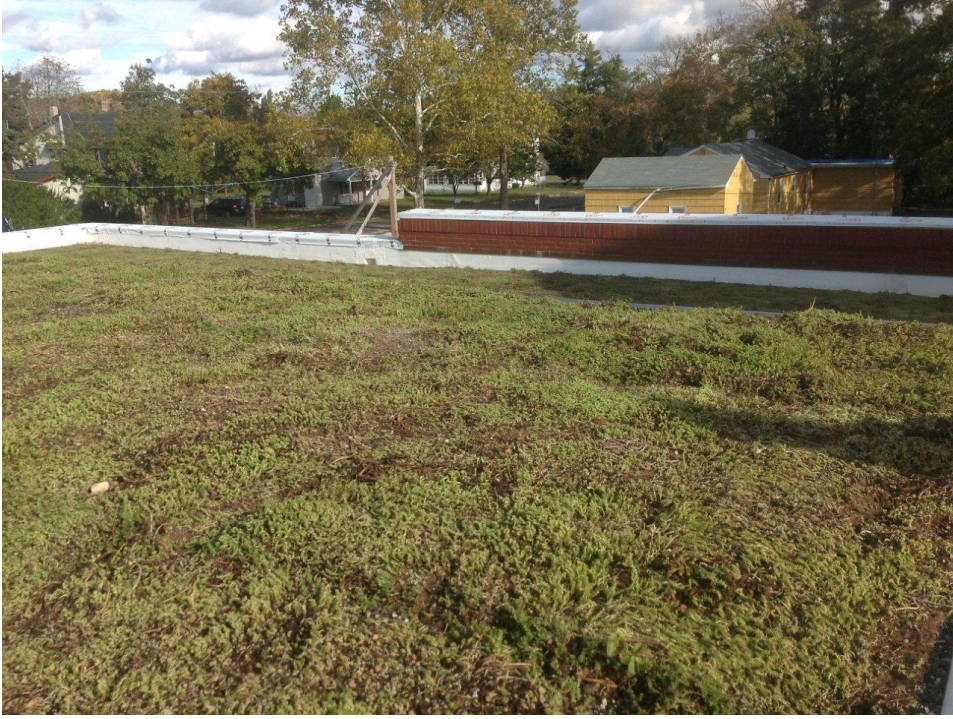
The photos that follow were taken on November 8th, 2012 approximately one week after the storm had passed and no remedial work had been performed. The green roof remained completely intact. There was no evidence of movement or peel-back of the vegetated sedum mats. While the plants appear slightly weather-beaten, they are in good health with no sign of dieback. The underlying tray system remained in its original position with little to no shifting or misalignments observed despite sustained winds estimated at 60 mph and gusts estimated to be 75 mph. The team which visited the site to inspect for damages surmised that the significant amounts of rainfall associated with Superstorm Sandy had saturated the sedum mat and growing media such that it was very heavy and therefore had little susceptibility to the high winds caused by the storm.

Figure 12: Post-storm photo of the Sam Azeez Museum green roof.

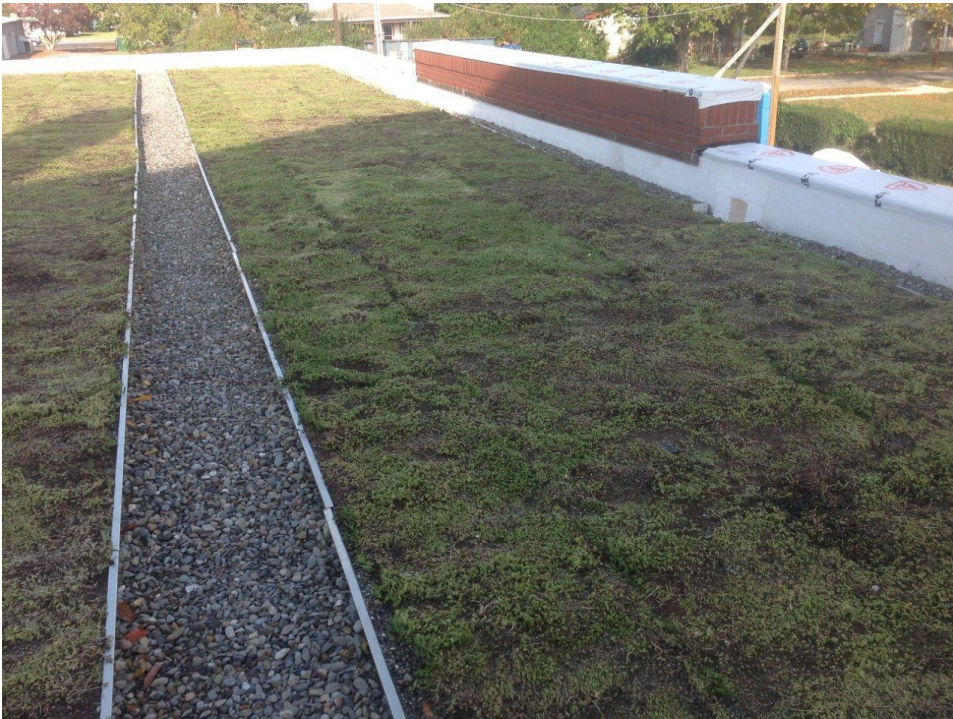
Figure 13: Post-storm photo of the Sam Azeez Museum green roof.
